IDENTIFICATION OF POST FIRE DAMAGE IN DHARMA BHAKTI MONASTERY BUILDING

J. Rilatupa, N. W. Priyomarsono, R. Surya, F. Liauw, J. Priyono

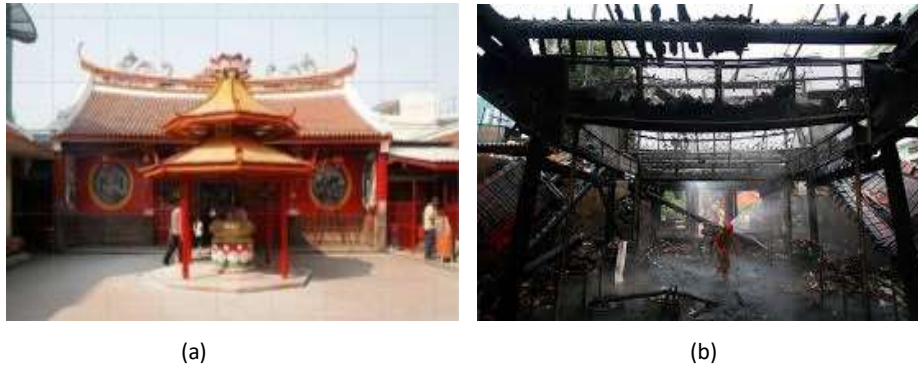
On March 2, 2015 at 03.00 WIB in the morning, Dharma Bhakti Monastery experienced a fire. The source of the cause is thought to come from candles and incense inside the Dharma Bhakti Monastery, then spread to the people's house. According to the monastery Management, there was one 1.5 meter high candle that fell, while the distance between the flame and the ceiling was close enough; because in 2014 the floor of the room was raised to avoid flooding. Fortunately, there were no fatalities in the incident even though the material loss was estimated at billions of rupiah. The main building of the temple was burned down (Figure 1).

Figure 1 Condition of Dharma Bhakti Monastery: (a) before and (b) after burning.
