# IDENTIFICATION OF POST FIRE DAMAGE IN DHARMA BHAKTI MONASTERY BUILDING

**J. Rilatupa, N. W. Priyomarsono, R. Surya, F. Liauw, J. Priyono**

## ABSTRACT

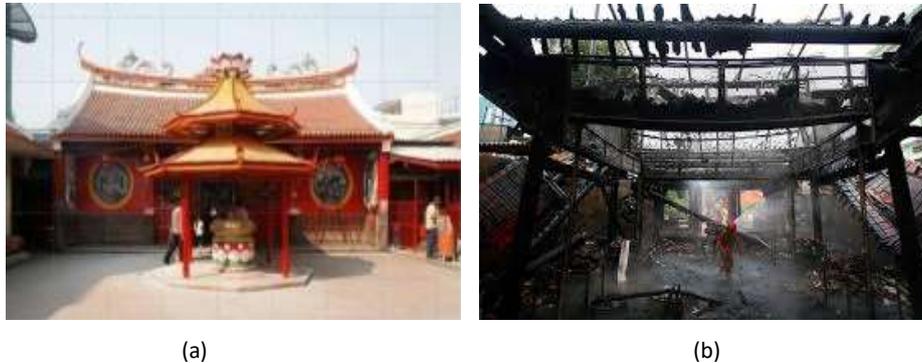
On March 2, 2015 at 03.00 WIB in the morning, Dharma Bhakti Monastery experienced a fire. The source of the cause is thought to come from candles and incense inside the Dharma Bhakti Monastery, then spread to the people's house. According to the monastery Management, there was one 1.5 meter high candle that fell, while the distance between the flame and the ceiling was close enough; because in 2014 the floor of the room was raised to avoid flooding. Fortunately, there were no fatalities in the incident even though the material loss was estimated at billions of rupiah. The main building of the temple was burned down (Figure 1).

**Figure 1** Condition of Dharma Bhakti Monastery: (a) before and (b) after burning.
