# Journal of Hunan University (Natural Sciences)

<https://doi.org/10.55463/issn.1674-2974.52.5.9>

## Analysis of Pavement Damage on Jakarta–Merak Toll Road Using PCI Approach

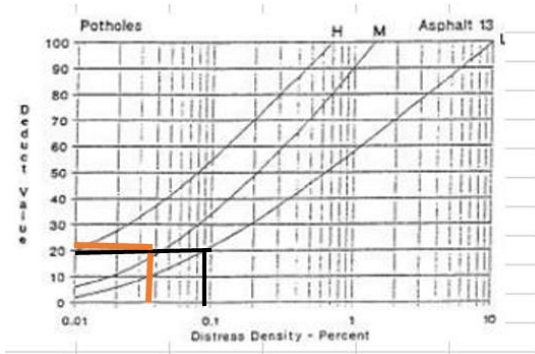
**Figure 3. Potholes reduction value graph for segment KM 35+300 – 35+900 (ASTM D6433 – 07)**  
Source: Developed by the authors (2025)

For example, segments KM 35+300 to KM 35+900 contained pothole damage categorized as both low and medium. The respective density values were 0.091 and 0.042, leading to deduct values of 20 and 21. These values are illustrated in the pothole reduction graph in Fig. 3.

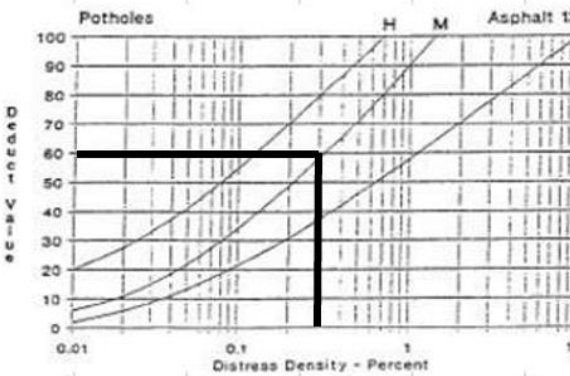
**Figure 4. Potholes reduction value graph for segment KM 86+200 – 86+950 (ASTM D6433 – 07)**  
Source: Developed by the authors (2025)

For segments KM 86+200 to KM 86+950 on Route A, three types of damage were recorded: potholes, block cracking, and corrugation. The low-severity pothole damage had a density of 0.01 (deduct value 2), and the medium-severity damage had a density of 0.3 (deduct value 60), as depicted in Figure 4. Block cracking damage at low and medium severities resulted in density values of 0.4 (deduct value 0) and 1.2 (deduct value 5), as shown in Figure 5. At medium severity, corrugation damage with a density of 0.3 at medium severity yielded a deduct value of 10, as illustrated in Figure 6.

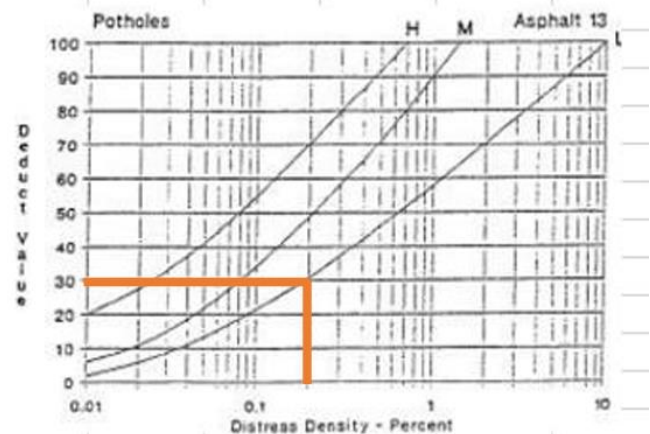
**Figure 7. Potholes reduction value graph (ASTM international D 6433 – 07)**  
Source: Developed by the authors (2025)

On Route B, at segments KM 53+270 to KM 53+900, the pothole damage had a low severity with a density value of 0.2, corresponding to a deduct value of 30 (shown in Figure 7), while rutting (groove damage) at medium severity had a density of 0.627 and a deduct value of 13, as shown in Figure 8.

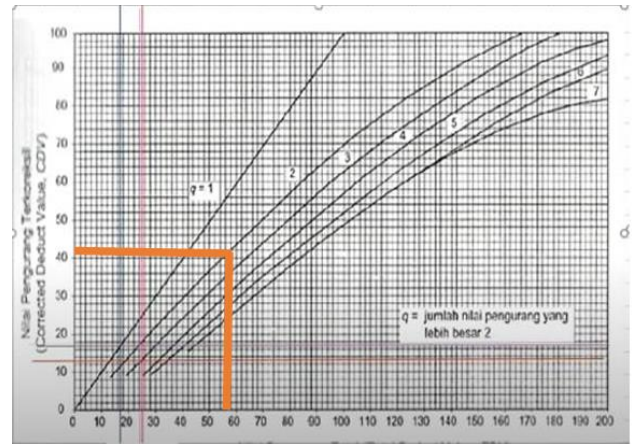
**Figure 9. CDV graph (KM 35+300 – 35+900) (ASTM international D 6433 – 07)**  
Source: Developed by the authors (2025)

The corrected deduct value (CDV) was derived by applying interaction correction using Equation 6, which considers the number of deduct values exceeding 2. At segments KM 35+300 to KM 35+900, a total deductvalue (TDV) of 41 and multiple deduct values greater than 2 resulted in a CDV of 42, as illustrated in Figure 9. Consequently, the PCI was calculated using Equation 7, resulting in a value of 58. A summary of HDV, TDV, total TDV, q value, and CDV for all Route A segments is presented in Table 4.

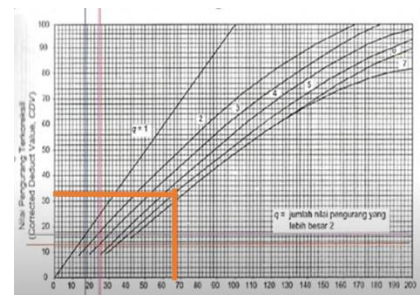
**Figure 10. CDV graph (KM 53+270 – 53+900) (ASTM international D 6433 – 07)**  
Source: Developed by the authors (2025)

Similarly, for Route B at segments KM 53+270 to KM 53+900, a total TDV of 43 and two deduct values greater than 2 led to a CDV of 33. This is illustrated in Figure 10. The corresponding PCI calculated using Equation 7 was 67. The detailed calculation of all the variables for Route B is presented in Table 5.
